**Flood Control Project Maintenance
Levee Inspections****LMA District Cover Sheet****Spring 2011 Levee Inspection Results****Tehama County Flood Control and Water Conservation District**

Spring 2011 Levee Inspection Results

Tehama County Flood Control and Water Conservation District

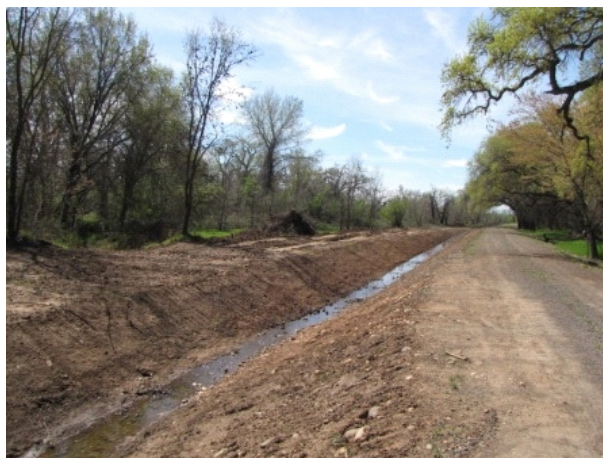
Levee Mile Report Line	1
Start Levee Mile	2.04
End Levee Mile	2.23
Location	Land Side
Category	Earthen Levee
Item	Encroachments
Remove agricultural ditch from toe of levee.	
rduffey_s_20110404_238.jpg

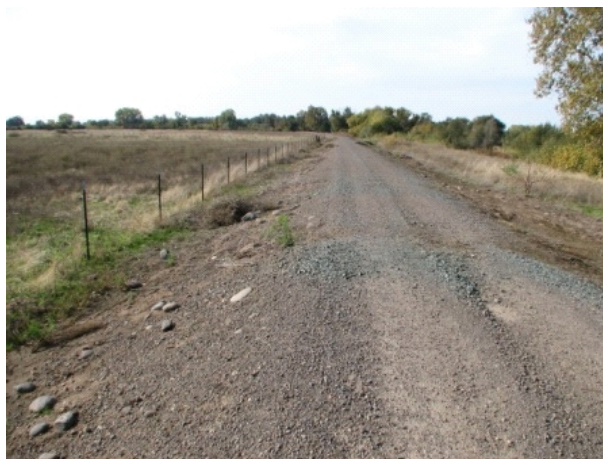
Levee Mile Report Line	3
Start Levee Mile	2.72
End Levee Mile	2.76
Location	Crown
Category	Earthen Levee
Item	Slope Stability
Erosion on crown and both slopes.	
rduffey_s_20110228_071.jpg

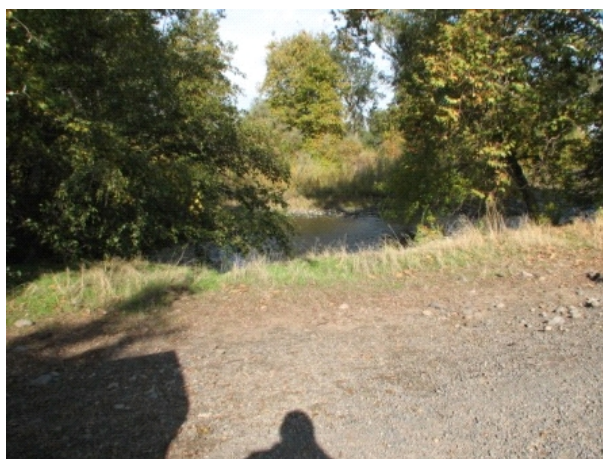
Levee Mile Report Line	4
Start Levee Mile	2.79
End Levee Mile	2.79
Location	Water Side
Category	Earthen Levee
Item	Erosion / Bank Caving
Erosion along the channel.	
rduffey_s_20110228_074.jpg

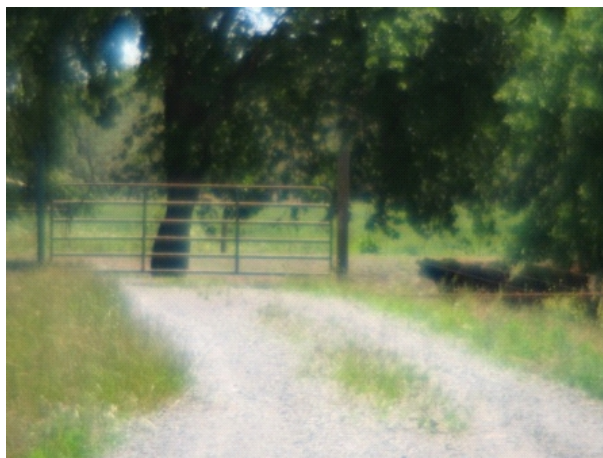
Levee Mile Report Line	8
Start Levee Mile	3.64
End Levee Mile	3.64
Location	Crown
Category	Earthen Levee
Item	Encroachments

View of the non-permitted gate on the crown of the levee.

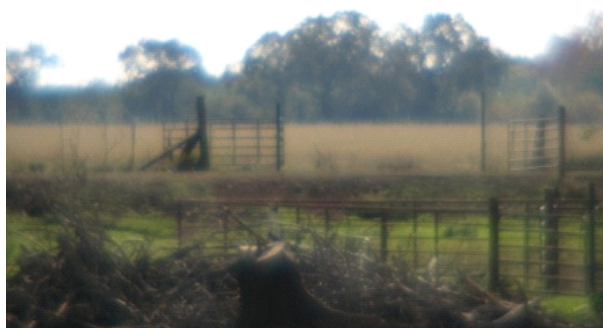
Levee Mile Report Line	9
Start Levee Mile	3.74
End Levee Mile	3.74
Location	Crown
Category	Earthen Levee
Item	Encroachments

View of the non-permitted gate on the crown roadway.

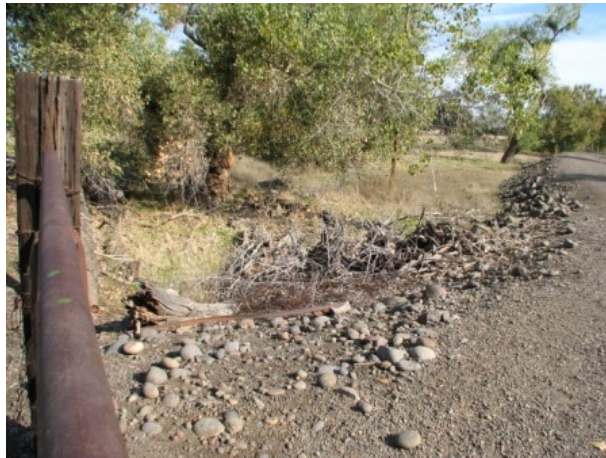
Levee Mile Report Line	1
Start Levee Mile	0.31
End Levee Mile	0.31
Location	Land Side
Category	Earthen Levee
Item	Encroachments

View of debris & wire at toe of levee.

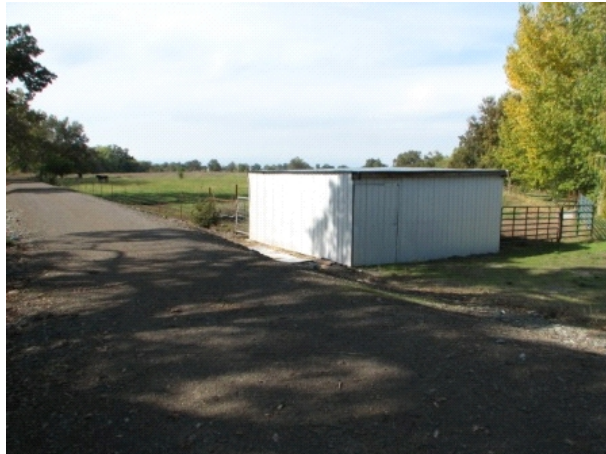
Levee Mile Report Line	2
Start Levee Mile	0.36
End Levee Mile	0.36
Location	Land Side
Category	Earthen Levee
Item	Encroachments

View of building at toe of levee.

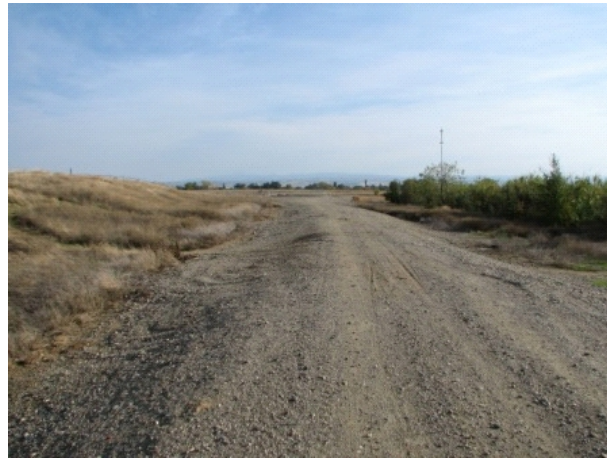
Levee Mile Report Line	1
Start Levee Mile	1.60
End Levee Mile	1.71
Location	Water Side
Category	Earthen Levee
Item	Slope Stability

View of vehicle erosion on the crown & both slopes.

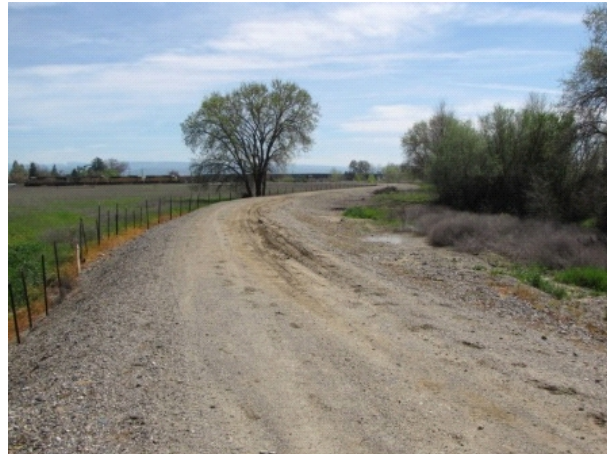
Levee Mile Report Line	2
Start Levee Mile	2.00
End Levee Mile	2.22
Location	Crown
Category	Earthen Levee
Item	Crown Surface / Depressions / Rutting

View of the crown roadway that needs gravel & grading.

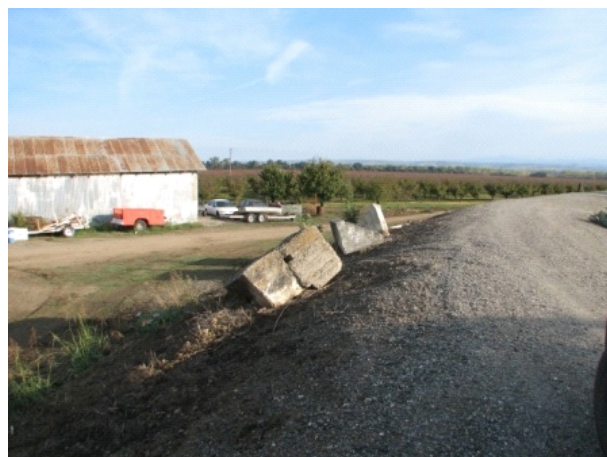
Levee Mile Report Line	9
Start Levee Mile	3.15
End Levee Mile	3.15
Location	Land Side
Category	Earthen Levee
Item	Encroachments

View of the concrete stairways on the slope.

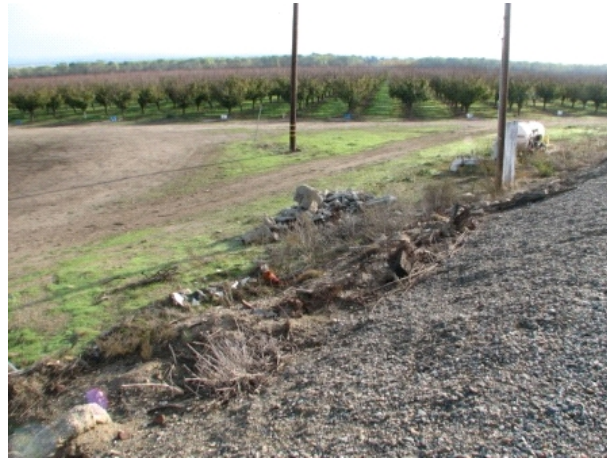
Levee Mile Report Line	10
Start Levee Mile	3.34
End Levee Mile	3.34
Location	Land Side
Category	Earthen Levee
Item	Encroachments

View of the garbage and metal at the toe of the levee & along the slope of the landside.

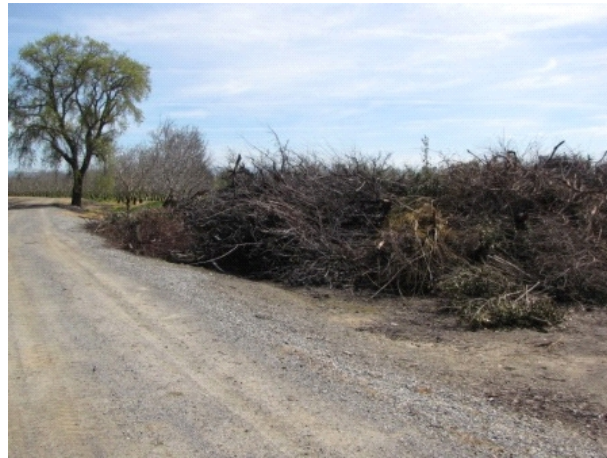
Levee Mile Report Line	1
Start Levee Mile	0.81
End Levee Mile	0.81
Location	Land Side
Category	Earthen Levee
Item	Encroachments

View of the debris & pruning pile brush next to the toe.

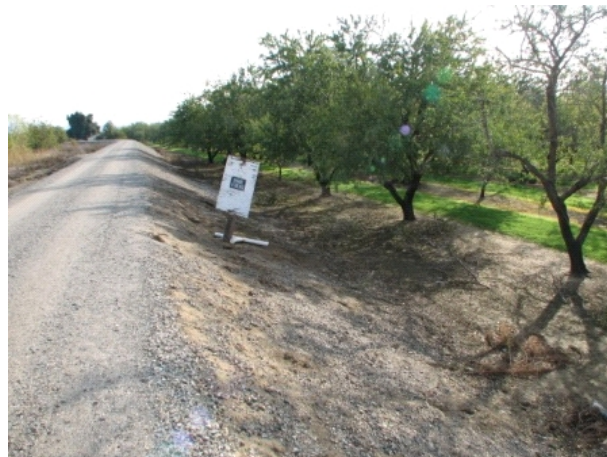
Levee Mile Report Line	3
Start Levee Mile	2.57
End Levee Mile	2.57
Location	Land Side
Category	Earthen Levee
Item	Animal Control

View of the bait station next to the squirrel holes on the landside slope.

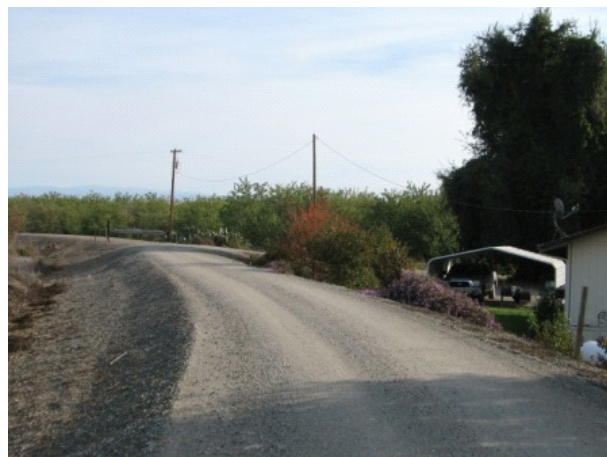
Levee Mile Report Line	4
Start Levee Mile	2.70
End Levee Mile	2.76
Location	Land Side
Category	Earthen Levee
Item	Encroachments

View of the landscape along the slope.
